**KOOTENAI DEVELOPMENT IMPOUNDMENT DAM
TOE DRAIN INVESTIGATION PROPOSAL**

February 22, 2008

BILLMAYER & HAFFERMAN ENGINEERING INC.

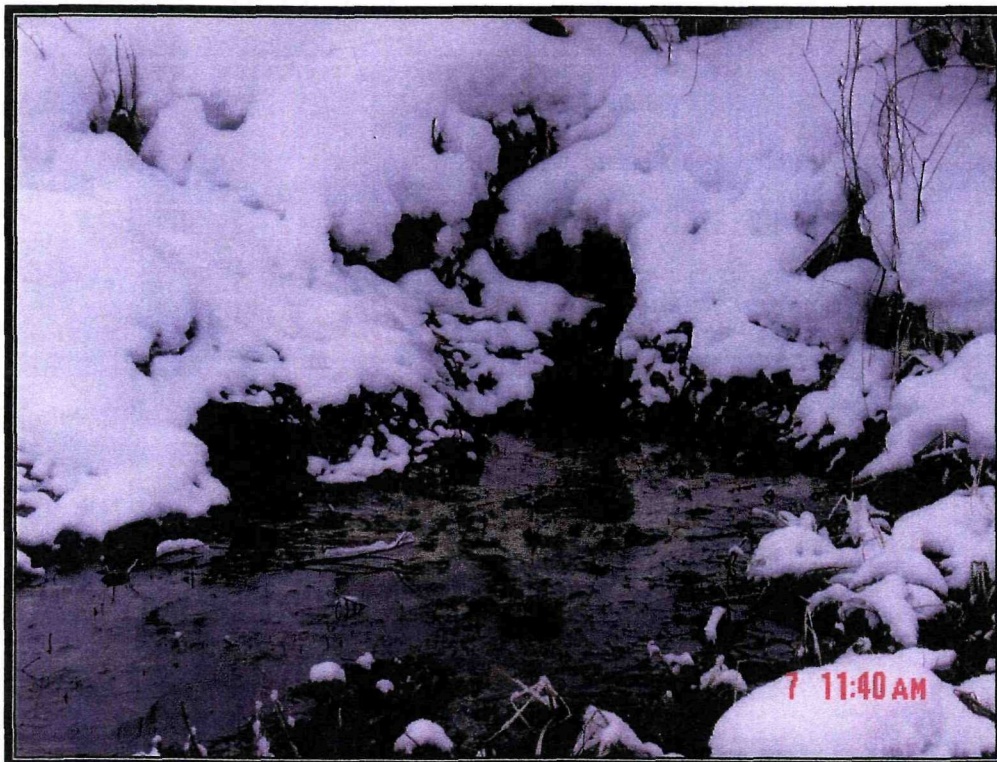
As the phreatic water surface in the dam remains low they do not appear to be causing long term effects yet but they must be cleared to assure no future problems with high phreatic water surface. We do note that there is water appearing on the outside of several of the drains which is a clear indication that the drains are not functioning properly. Shown below are two photographs that show water flow on the outside of the drains. Figure 1 is the wet area where flow appears at the base of Drain 7 and Drain 8 which are in the center of the dam. Figure 2 is flow on the outside of Drain 12 which is in the far right groin at the toe of the dam.

Figure 1 Flow on the Outside of Drain 7 and 8

.As concerns have been raised about the removal of brush on the dam we will post pone that project until a final plan for drain repair has been developed. We still believe it will be necessary to eventually remove more of the vegetation at the toe of the dam to make sure that the roots that are invading the drains are removed and to provide the best possible access for investigating the drains and to track any water that appears on the outside of the drains. This project would involve removal of two medium sized cottonwood trees, some of the willow trees and the larger brush within 20 ft. of the stream.

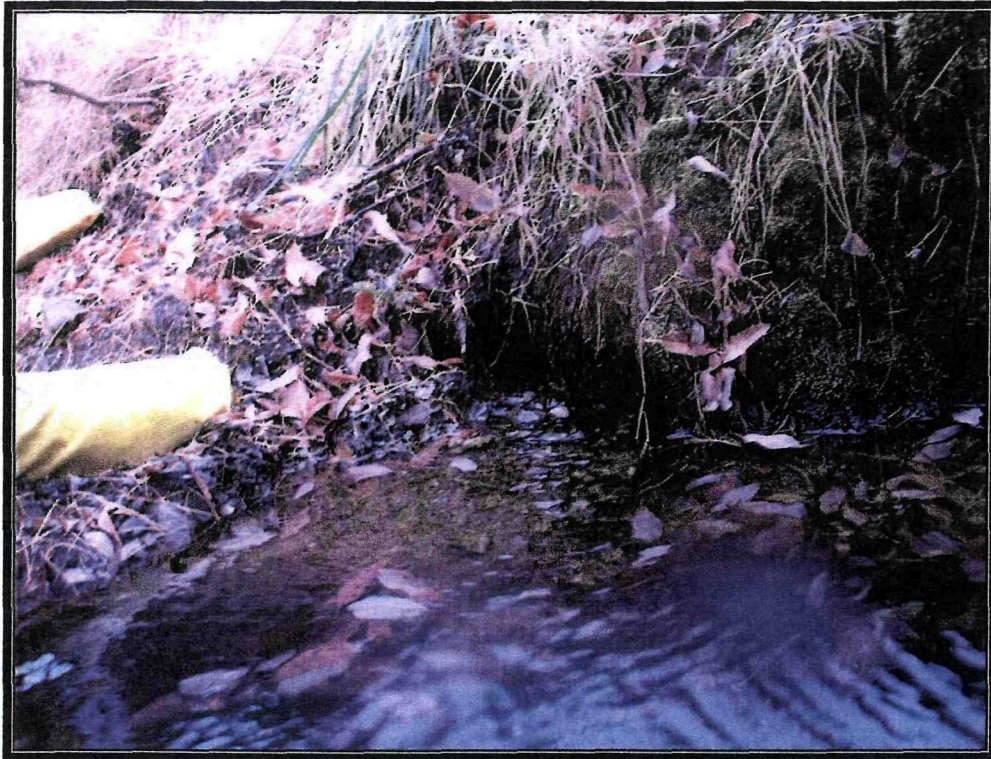
Figure 2 Flows on the Outside of Drain 12
